Second Five-Year Review Report  
for  
Raymark Industries, Inc. Site  
Stratford, Connecticut

September 2005

The United States Environmental Protection Agency  
Region 1, New England  
Boston, Massachusetts

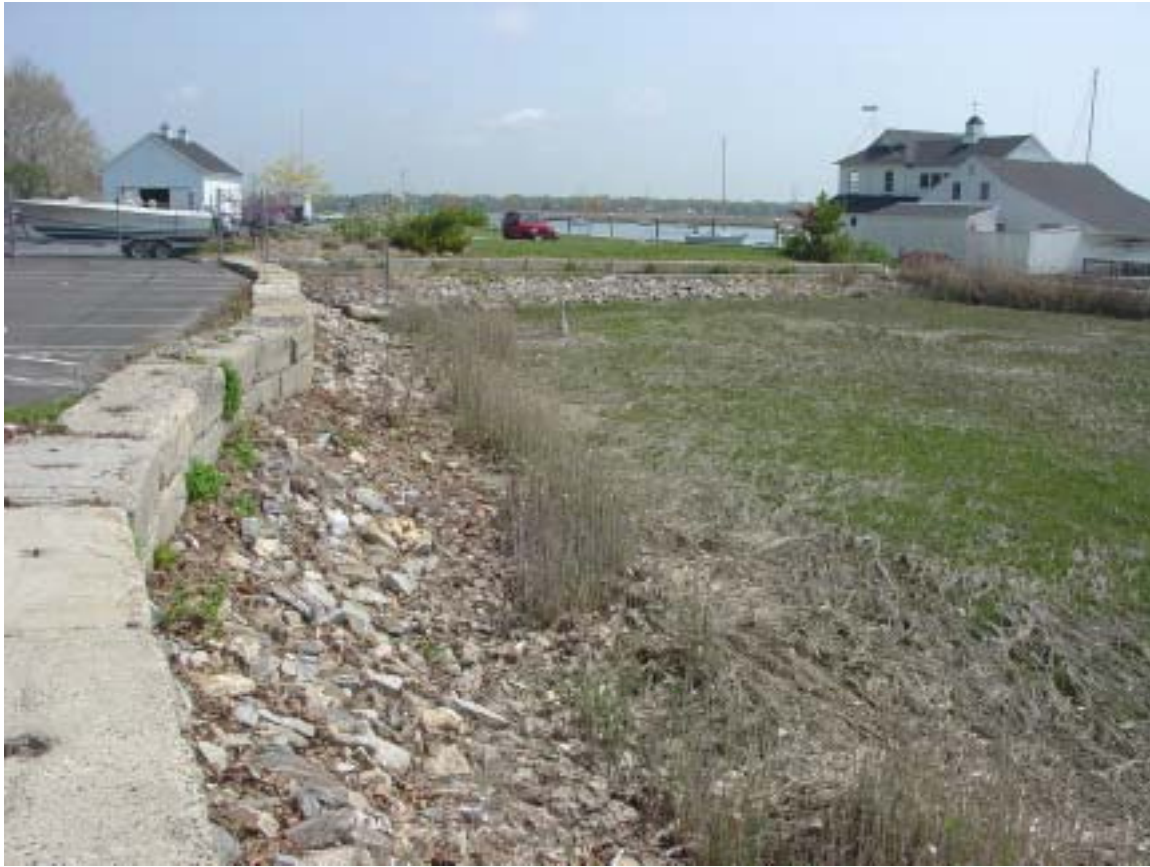
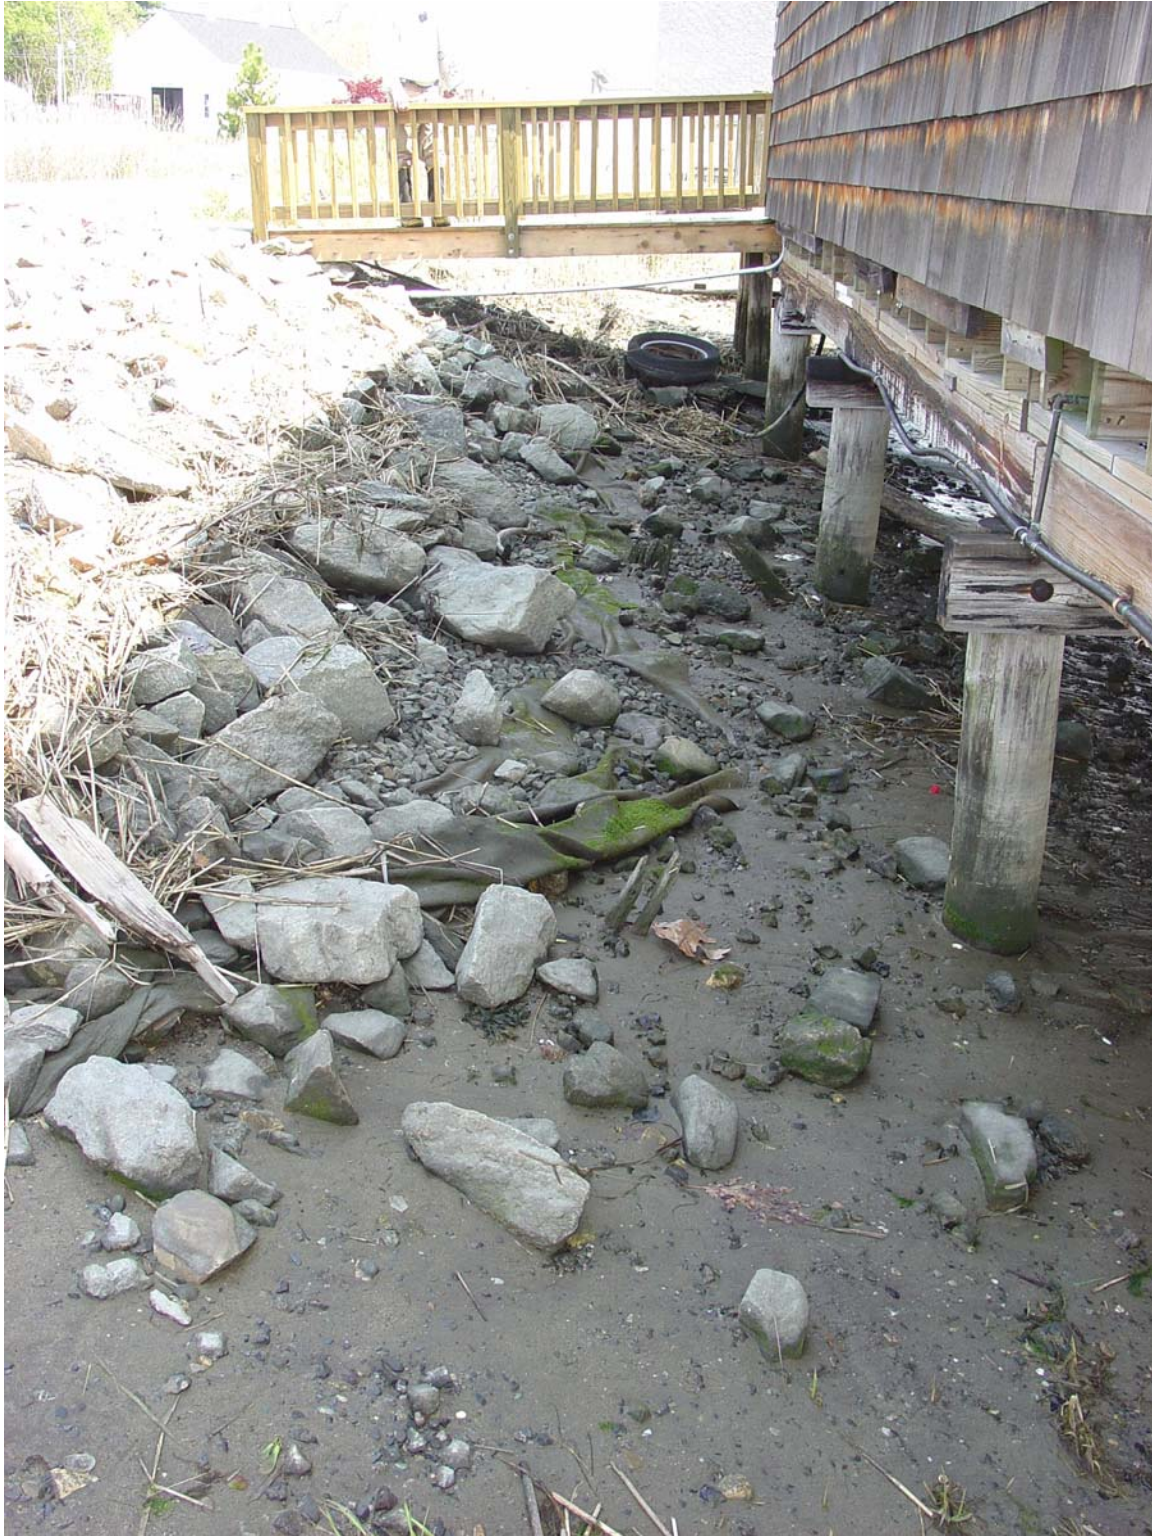
Other general site condition photos are shown below. See next 4 photos.
